Manhole Inspection Summary

Manhole # S21AA1001MH

Insp Date: **1/30/07 2:38 PM**

Location Address: **2002 OAKINGTON ST**

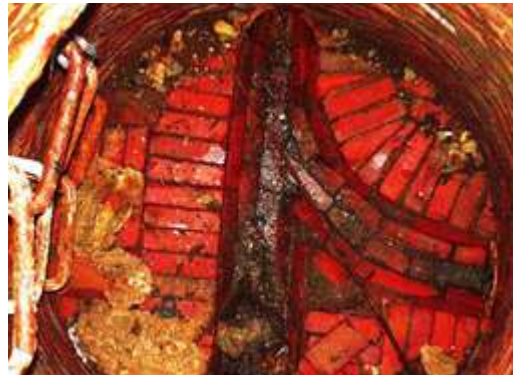
Top View

Infiltration: ☐ None ☐ Joint ☐ Cracks ☐ Mortar ☐ Roots ☒ **Wall**

☒ **Debris** (not Condition related)

Count: **7** Missing: **0** ☒ **Corroded**

Barrel infiltration. Bench and Channel debris. Corroded steps.

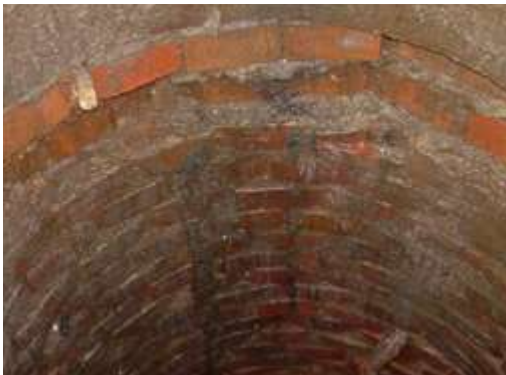
Defect

☒ **Leaks**

Condition: ☐ Sound ☐ Cracked ☐ Root Intrusion ☐ Loose Brick ☒ **Deteriorated**

Infiltration: ☐ None ☒ **Joint** ☐ Cracks ☒ **Mortar** ☐ Roots ☐ Wall

Frame leaks. Adjustment deterioration and infiltration.

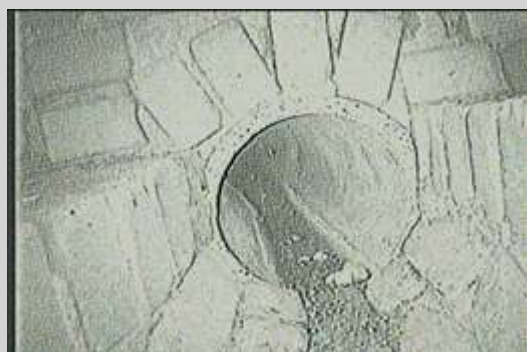
Pipe In @ 3 O'Clock

Deposits: ☐ None ☒ Mud ☐ Sludge ☒ Debris ☐ Grease

Silt Depth: **0.5** (in.) Deposits Extent: **Light**

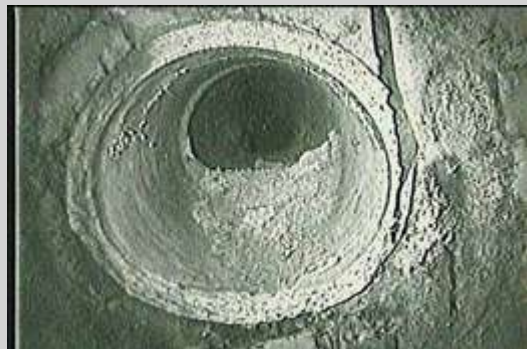
Pipe In @ 6 O'Clock

Deposits: ☐ None ☐ Mud ☐ Sludge ☒ **Debris** ☒ **Grease**

Infiltration: **Evidence**

Pipe Seal Cond: **Cracked**

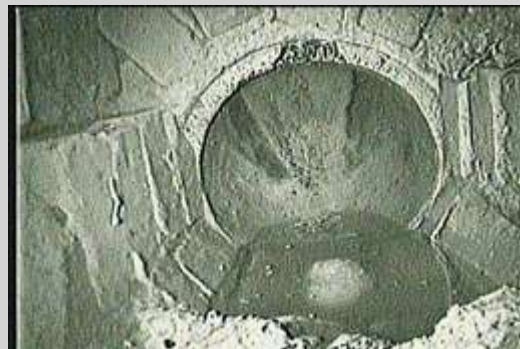
Drop In @ 6 O'Clock

Drop Condition: **Partly Clogged**
